Manhole Inspection Summary

Manhole # S35GG1018MH

Location Address: **209 KEMBLE RD**

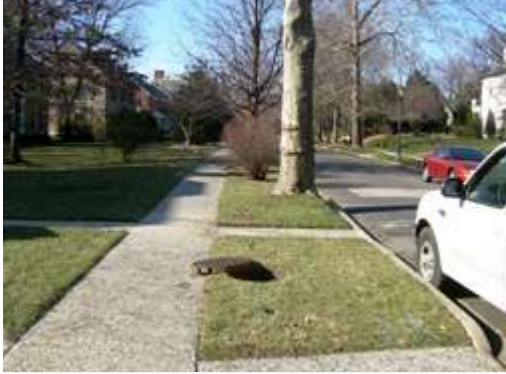
Location View

Comments **The Mh is located infront of 207. Fix map.**

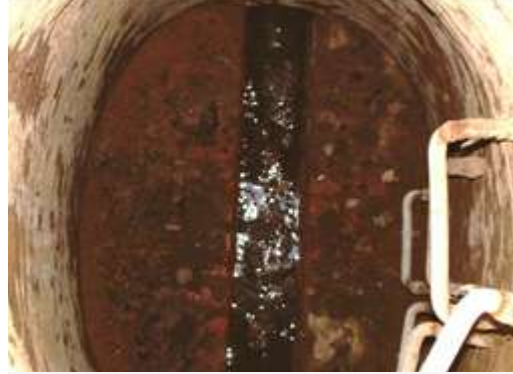
Top View

Corroded steps. Evidence of surcharge - Bench debris. Channel debris.

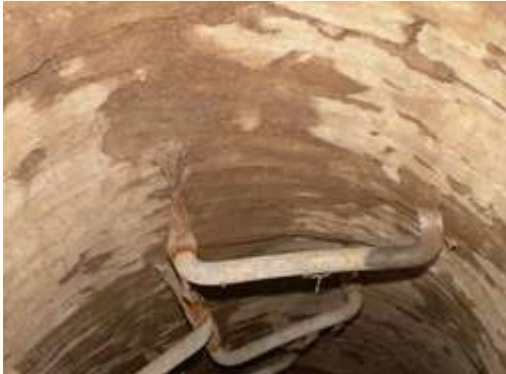
Defect

Infiltration: ☐ None ☒ Joint ☐ Cracks ☒ Mortar ☐ Roots ☐ Wall

Infiltration: ☐ None ☐ Joint ☐ Cracks ☒ Mortar ☐ Roots ☒ Wall

Adjustment, Corbel and Barrel infiltration.

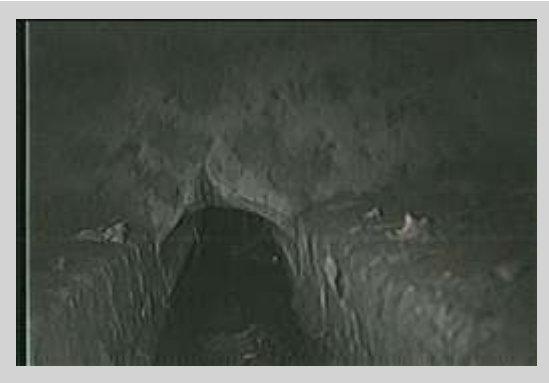
8 in. Circular Gravity Sewer Pipe Out @ 12 O'Clock

Deposits: ☐ None ☒ **Mud** ☐ Sludge ☒ **Debris** ☐ Grease

Silt Depth: **0.5** (in.) Deposits Extent: **Light**

Infiltration: **Evidence** Pipe Seal Cond: **Cracked**

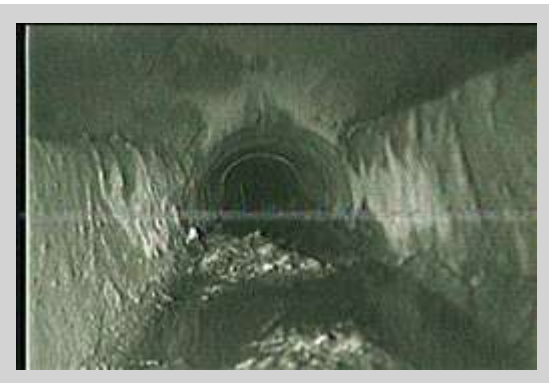
8 in. Circular Gravity Sewer Pipe In @ 6 O'Clock

Deposits: ☐ None ☒ **Mud** ☐ Sludge ☒ **Debris** ☒ **Grease**

Silt Depth: **1** (in.) Deposits Extent: **Light**

Infiltration: **Evidence** Pipe Seal Cond: **Unknown**
